Causes of pavement failure of Edunabon – Sekona road, Osun State, Nigeria

Hussein Mohammed

Department of Civil Engineering, Obafemi Awolowo University, Ile-Ife, Nigeria

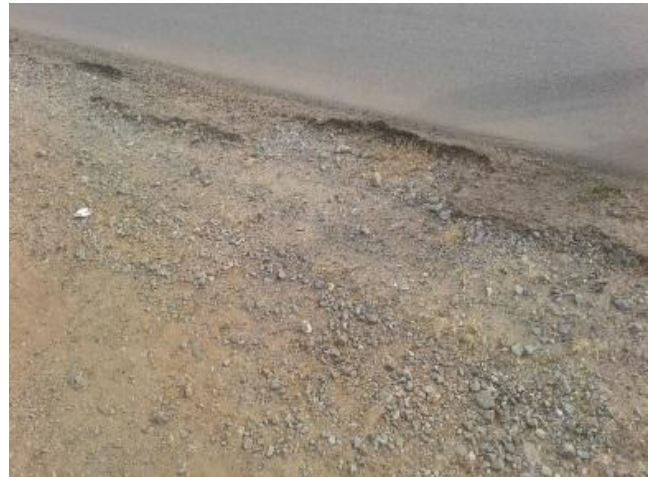
(a) Edge and Shoulder Damage

Plate 2. Failures at CH. 0+000 – 0+500

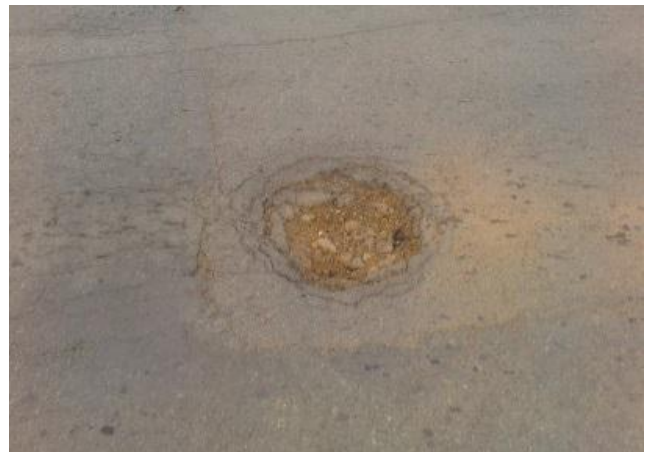
(b) Pothole

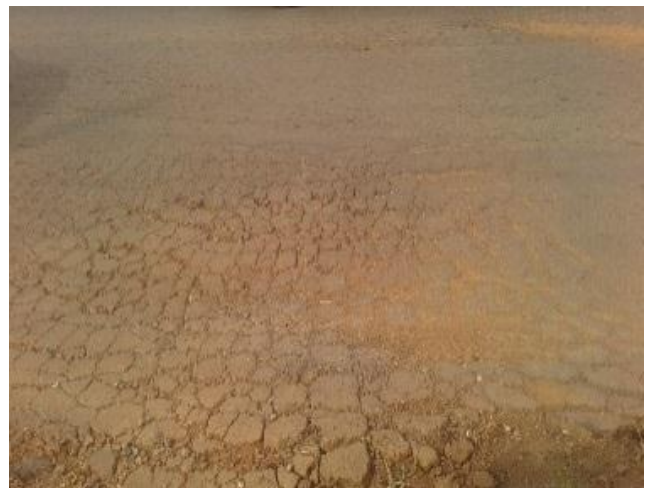
(c) Alligator Cracks

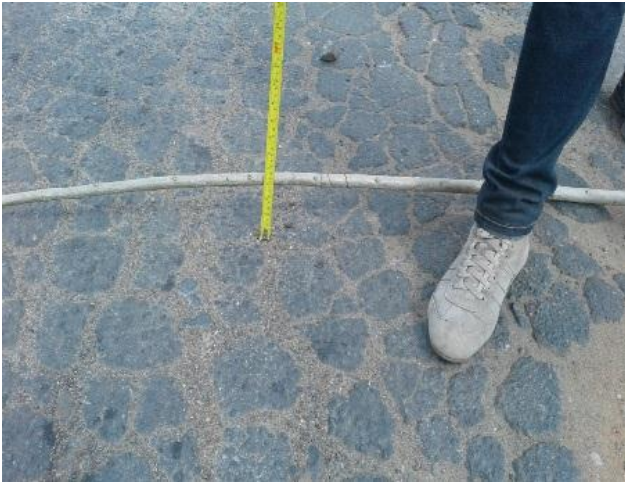
Plate 3. Rutting Btw. CH. 3+000 and CH. 3+500

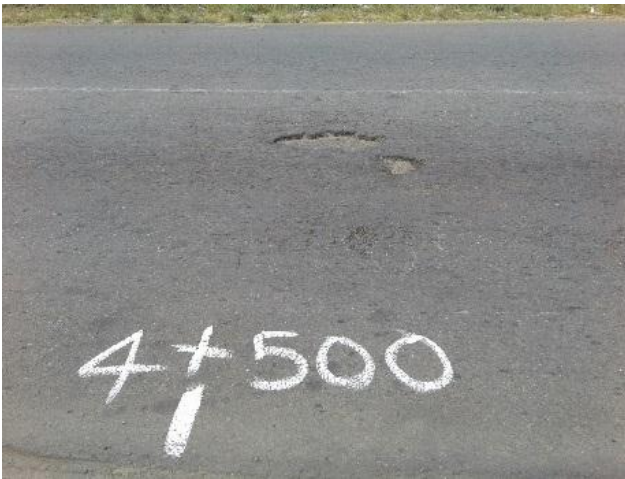
Plate 4. Delineation at CH. 4+500

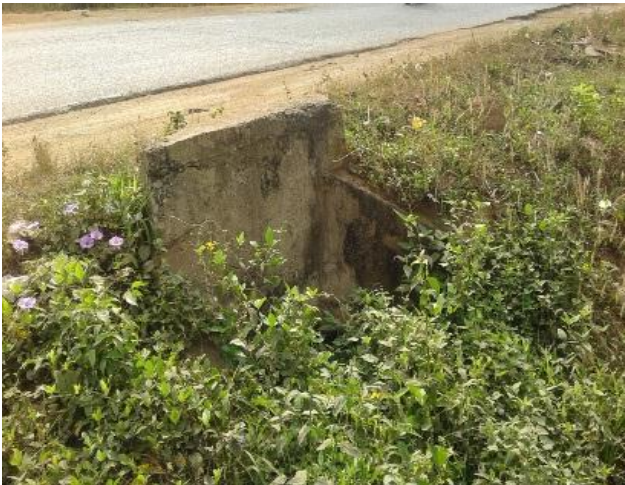
The road starts at Edunabon and ends at Sekona and traverses through Agbungbu village. It is a Federal road plied by all types of vehicles. It is a flexible pavement with a carriage width of 7.5 m and a 2.75 m wide shoulder; this conforms to the Federal Ministry of Works and Housing specifications [20]. Its cross section consists, of 100 mm asphaltic concrete surfacing, 150 mm stone base and 150 mm sub base lateritic soil. There is no road furniture except for the milepost. There are widespread and varied distresses on the pavement as shown on Plate 2a-c. edge and shoulder damage, pothole, and alligator cracks respectively. Others include, rutting (Plate 3) and delineation (Plate 4) [21]; [22]. There are no intersections within the stretch of the route. The drainage structures along the route include 4 no. pipe culverts (at chainages, 1+500, 2+700, 3+650 and 5+000) and 3 no. box culverts (at chainages 0+500, 1+000 and 1+600). Most of the culverts are in poor service conditions. The culvert at chainage 4+500 is in such a condition as shown on Plate 5, silted and over grown with weeds.

Plate 5. Culvert Inlet at CH. 4+500 Overgrown

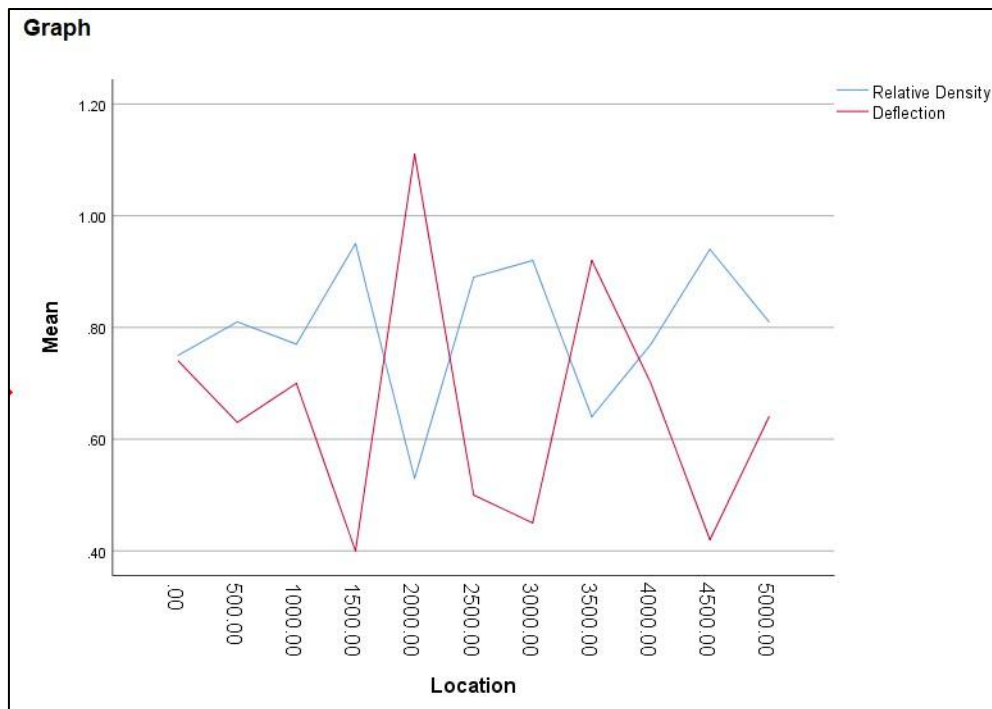
Fig 1. Relative Densities and Deflections of Route

The deflection and relative density graphs for the route are shown in Figure 1. It shows the relationship between the relative density and the deflections. The average deflection value for the route is 0.66 mm, while its representative rebound deflection value is 1.10 mm. Using the template in Table 3 [18], the pavement has failed. The template is based on minimum relative density (RD) of 95 % for embankment construction by [13], and 100 % relative density (RD) specification by Federal Ministry of Works and Housing, 1997 [18].
